Mine clean-up in Northwest Territories of Canada

Volume 328

June, 2011

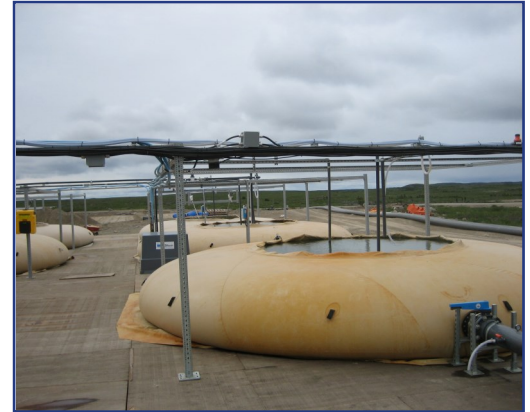
On left, bench testing was completed to optimize the chemical doses. On right the chemical addition was done in sequence using temporary “onion” tanks and the flow was by gravity between tanks and to the Geotube® containers.

Bench Testing of the water was done onsite to confirm the treatment of ferric sulfate, lime and polymer to precipitate the arsenic as a hydroxide. The precipitating solids could then be collected into the Geotube® containers. The Geotube® containers are made of polypropylene fabric and designed to allow the effluent water to escape while retaining the chemically conditioned solids.

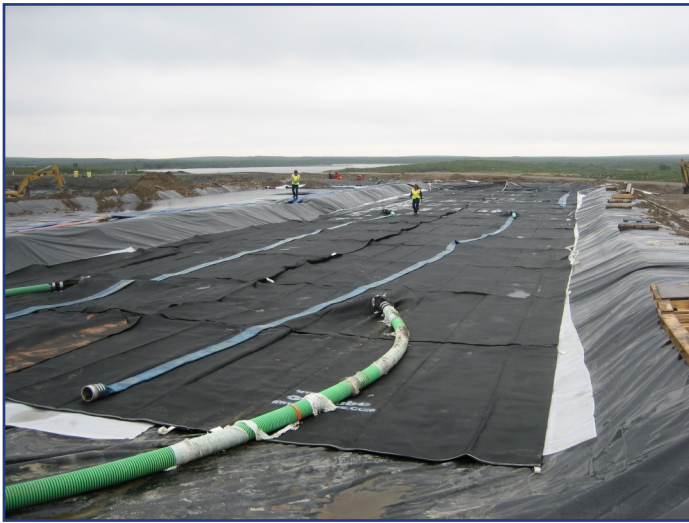
Two 45' circumference by 200' length Geotube® containers were placed for each treatment train and connected with hoses.

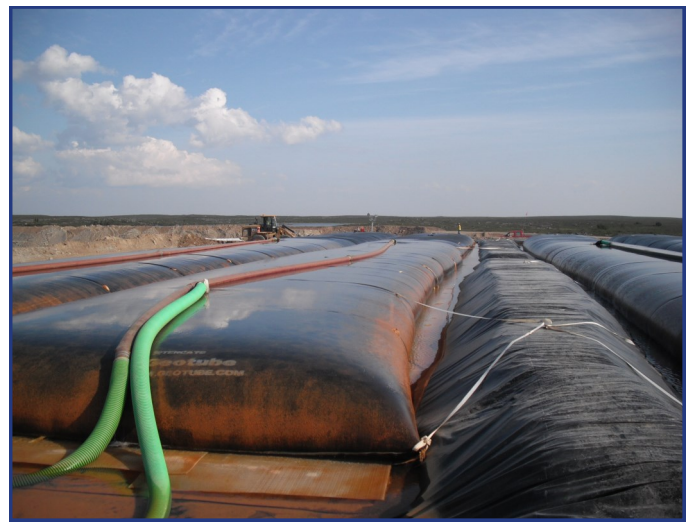
The Geotube® containers under full scale operation.

In this meeting, we also discussed the operation of the Geotube® containers. In the past, it has been necessary to break the surface tension by striking the tubes with a PVC pipe. Our recommendations were to only do that as necessary to keep the Geotube® containers below the maximum fill height and to do it on the top and if possible, only at the downstream area where the depth is greatest, and to avoid it if significant solids are released consistently while relaxing the tubes. It is anticipated that this will be required less than previous years because there are two tubes per treatment train.
