Nevada Gold Mine

Volume 341

May, 2014

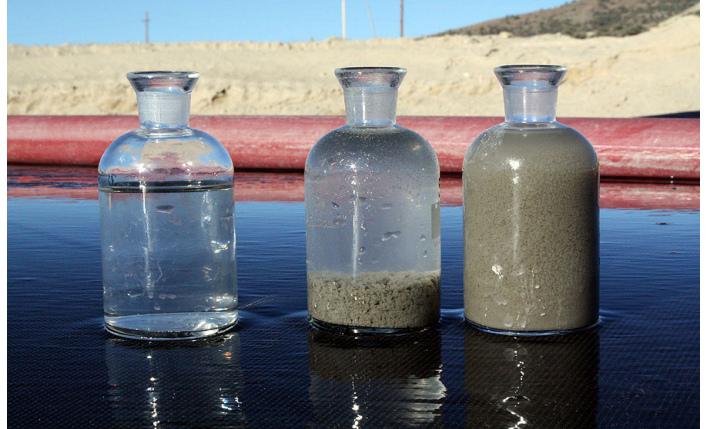
(Right to Left) Carbon fines, carbon fines conditioned with Solve 9330, filtrate.

A sample was sent to WaterSolve's lab for bench testing. Dewatering polymers were evaluated based on water release rate, water clarity, and flocculent appearance. Solve 9330 exhibited excellent results and would meet or exceed the site objectives. Filtrate coming out of the Geotube® container would be redirected back to the pregnant pond.

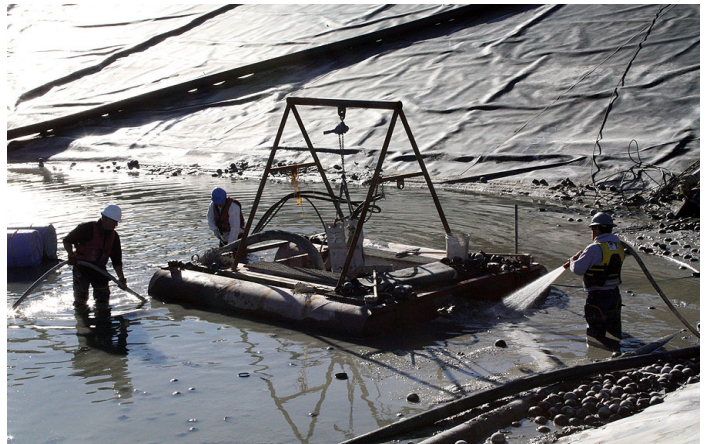
Pump required to overcome almost 500' of head was mounted on floats.

Gold deposits were discovered at the Nevada mine in 1864. Before any new mining operations could begin they needed to repair the pregnant and barren pond liners to meet regulatory requirements. Approximately 400cy of carbon fines were dredged and dewatered from the barren pond prior to replacing the old liner. An 80 hp centrifugal hydraulic pump was used to dredge the fines from the pond and overcome the 500 feet of head to the lay-down area.

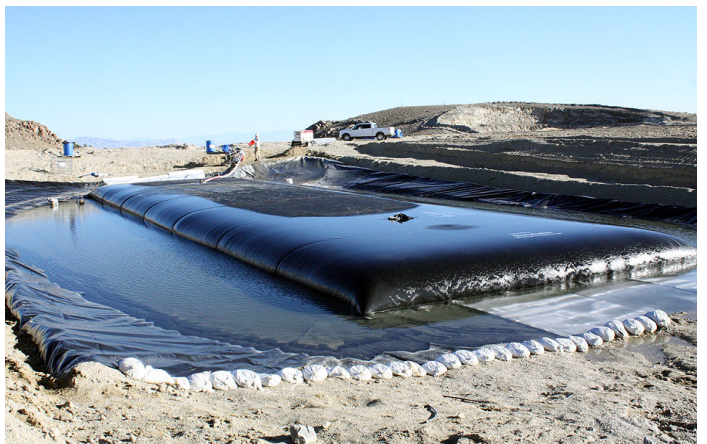
Lay-down area with Geotube® container being filled.

Geotube® Containers are manufactured from high strength polypropylene fabric and designed to allow the effluent water to escape through the pores of the fabric while retaining the chemically conditioned solids. One 45' x 100' Geotube® container was used to dewater and contain the solids.
