# Geotube® Shoreline Protection and Breakwater Construction Bring Cancun Beaches Back To Life

**Millions of Dollars of Property and Tourism Are Restored And Permanently Protected Using Geotube® Marine Structures Technology.**

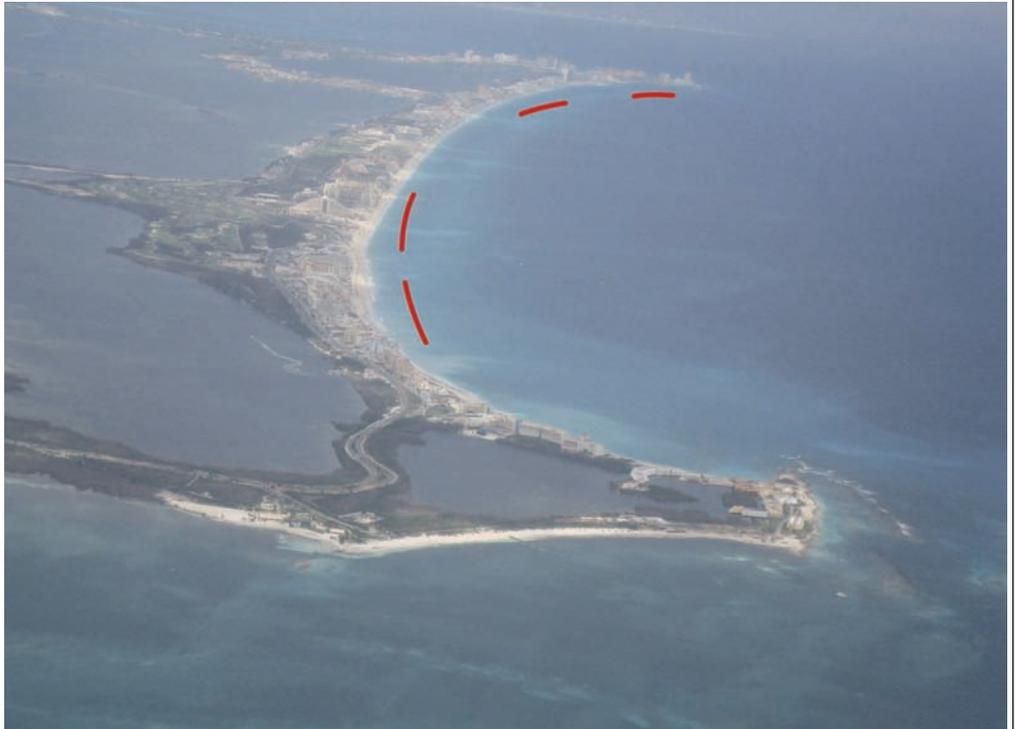
*The red lines indicate the placement of a 4-section breakwater off Cancun's shoreline built with Geotube® containers. By changing wave patterns, this will help replenish the hurricane-damaged beach and protect ocean-front resort property from future erosion.*

In May of 2007, TenCate began offshore submerged breakwater construction to function as the original sandbar that was destroyed. The submerged Geotube® breakwater was engineered to encourage beach replenishment by altering the water flow and wave patterns. This third and final phase, due to be finished before the '07 hurricane season, will help provide permanent protection of the beaches.

The tubes and scour aprons were connected on the shore, floated out into the water, secured by divers, and then pumped with sand fill under water. The finished breakwater is submerged 12 to 17-feet, with the top 3 to 4-feet below water level. A total of 80 Geotube® units were used, each one measuring 8-feet tall, 75-feet long and 18-feet wide. There were 20 tubes in each of four sections, creating a structure about 1,300 feet long.

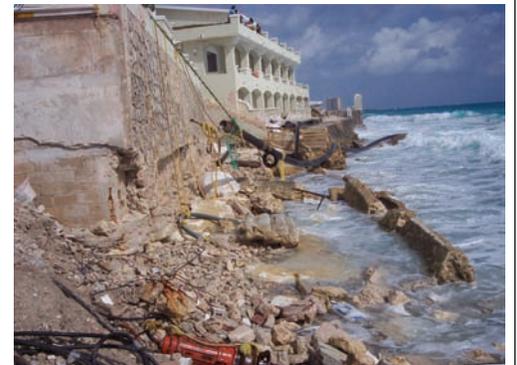
*(More) Total devastation was the scene as far as the eye could see in the aftermath of Hurricane Wilma in 2005.*

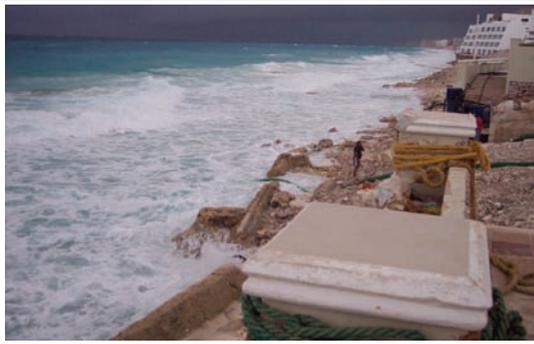
Before TenCate was called in. The beach had been erased.

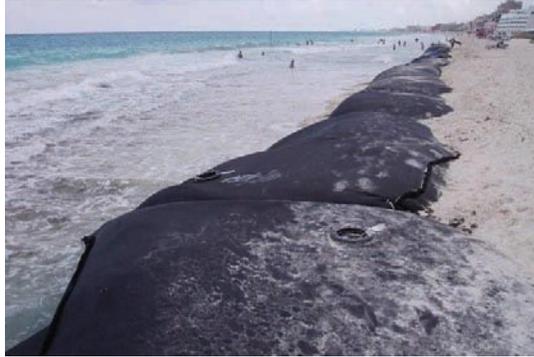
A total of 1.24 miles of Geotube® units were used for emergency protection and restoration.

The immediate goal was to protect the property that was left and prevent further deterioration. This emergency protection was accomplished by installing 1.24 miles of Geotube® units in the summer of '06 in front of property structures on the badly damaged beach.

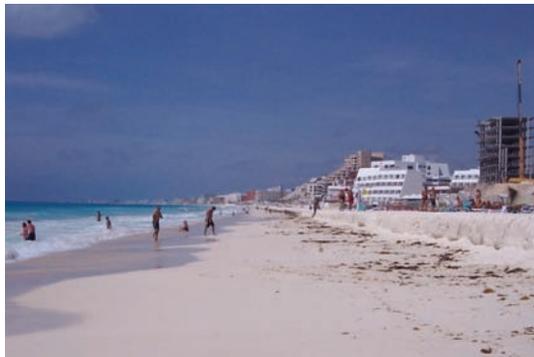
The same view, after Geotube® repair and restoration technology. The beach is coming back.

That same summer, with the Geotube® units in place, a dredging ship, collecting sand from 13 miles out in the Gulf, pumped sand onto the shoreline to begin restoration of the beach areas. Today the beaches are 60 to 100 feet wide.
