Environmental Cleanup of the Whitefish River

Objective

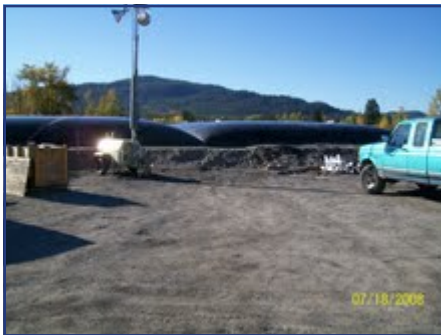
Containment area with Geotube® containers filled .

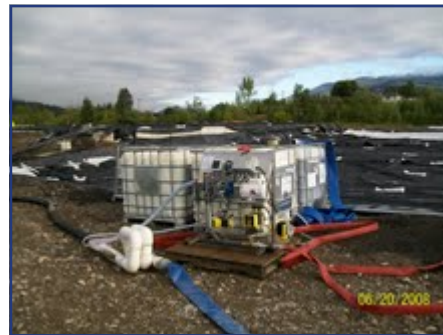
The chemical conditioning unit and totes of Solve 152 and Solve 426.

Two polymer makedown systems were provided by WaterSolve LLC. Solve 216B & Solve 426 were determined to be the most efficient polymers to flocculate the solids from the sediment before going into the units. A containment system was built and lined in order to prevent the effluent from contaminating the ground before it was returned into the Whitefish River. Geotube® units were sent to the site in Whitefish, Montana and were installed in the containment area.

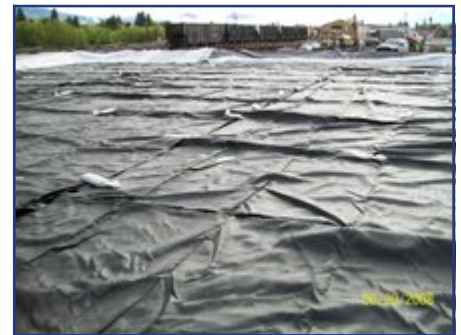
Containment area preparation.
