DEWATERING CONTAMINATED SEDIMENT FROM SEAPLANE LAGOON

Volume 302

June, 2011

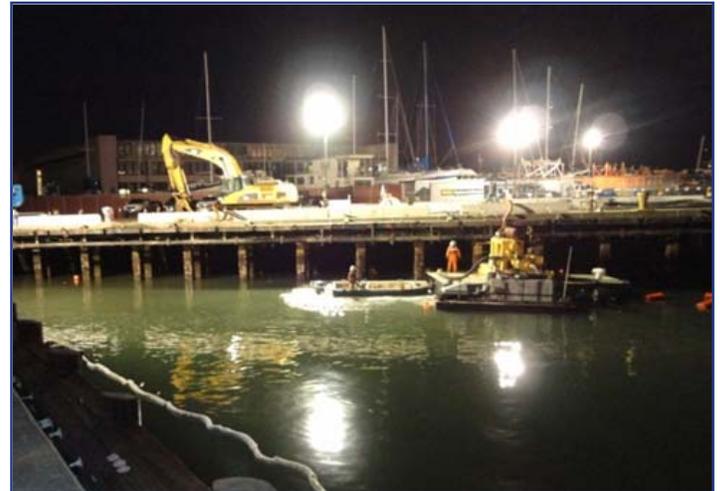
During low tides, the dredge crew systematically maneuvered a hydraulic dredge between the pillars underneath this elevated roadway to remove the contaminated sediment.

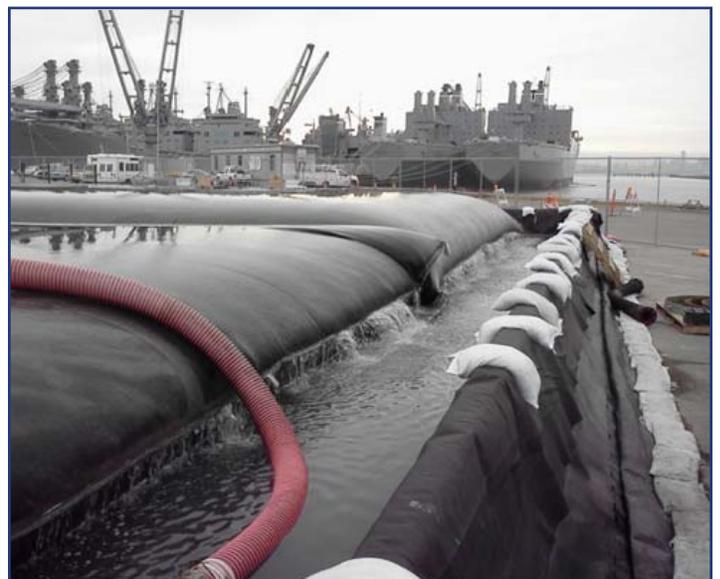
The Geotube® containers are releasing clear filtrate water as they are filled with chemically conditioned material.

Geotube® containers are manufactured from high strength polypropylene fabric and designed to allow effluent water to escape through the pores of the fabric while retaining the chemically-conditioned solids. Estimates suggested approximately 2,500 cubic yards of contaminated sediment needed to be removed and dewatered. The containment area was designed to fit four 75' circumference by 100' long GT500 Geotube® containers. Two 75' circumference by 68' long GT500 Geotube® containers that could be stacked on top if necessary.

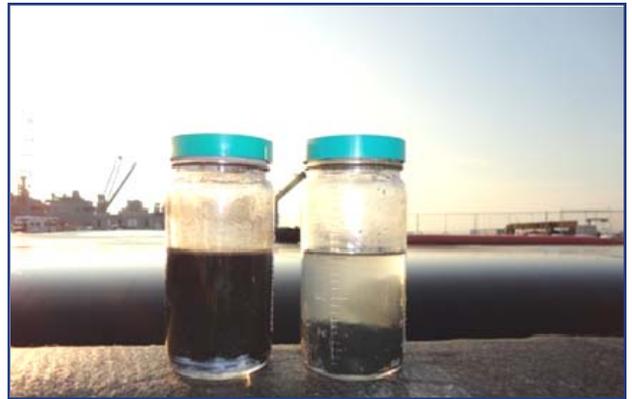
The in situ sediment sample compared to a chemically conditioned sample.

In June of 2011, WaterSolve, LLC received samples of the seaplane lagoon sediment. A dewatering performance trial was performed to determine the most effective chemical conditioning program. Dewatering polymers were evaluated based on water release rate, water clarity, and flocculent appearance. A chemical conditioning program consisting of Solve 9330 performed the best during the trial and was recommended for the project.

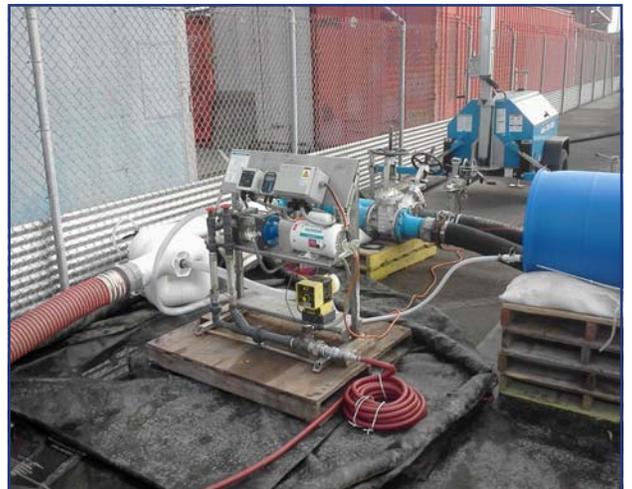
A polymer make-down unit and mixing manifold delivering Solve 9330 into the 6" pipe line.

WaterSolve LLC was contracted to dewater the seaplane lagoon residuals into Geotube® containers. A concrete containment area was prepared on the site with Geotube® Filtration Fabric placed underneath the Geotube® containers to allow maximum dewatering. A polymer make-down unit and mixing manifold were plumbed into the 6" dredge line to inject the flocculent Solve 9330. A sample port was placed prior to the Geotube® containers to provide visual observation of the treated residual and to determine if the polymer feed rate needed to be adjusted. A specially designed dredge maneuvered underneath the roadway and delivered the contaminated sediment to the Geotube® containers using water jets and a booster pump. The pumping rate of the dredge during operations was 500 to 700 gallons per minute. Dredging was performed during low tides in order for the dredge to reach the contaminated material underneath the roadway. The water released from the Geotube® containers was collected in a sump and was pumped to a large holding tank. This water was monitored for contaminants and treated if necessary before returning to the bay. The WaterSolve technician checked the sample port regularly and adjusted the feed rate of the Solve 9330 for optimum dewatering performance. During the dredging operations, the Geotube® containers each reached maximum fill height several times and the project was complete after survey results indicated appropriate sediment removal.

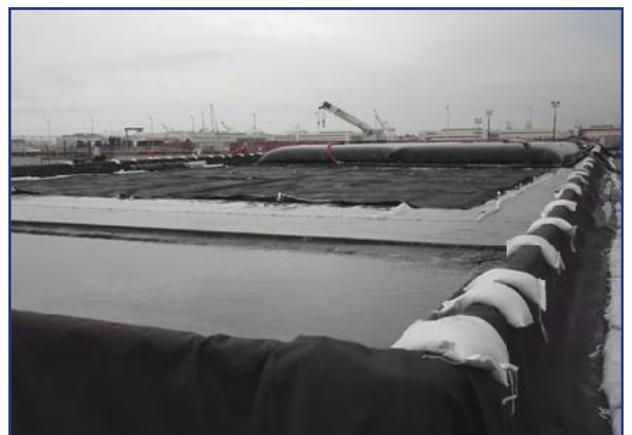
The first two Geotube® containers are near maximum capacity. The second two are rolled out and ready to be filled.
