## Dewatering Iron Backwash Residuals from WTP

Volume 318

March, 2013

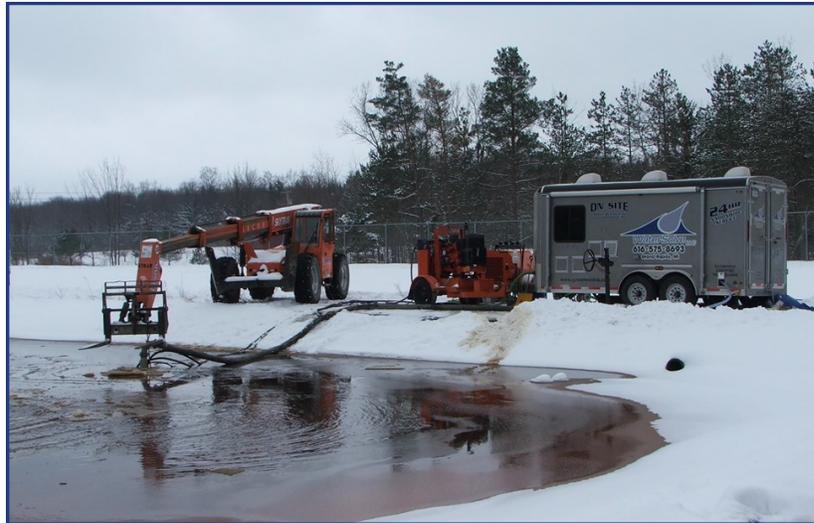
For protection from the weather, WaterSolve's Chemical Control and Tracking System Trailer was used to house the polymer and the polymer make-down unit during the cold weather operations.

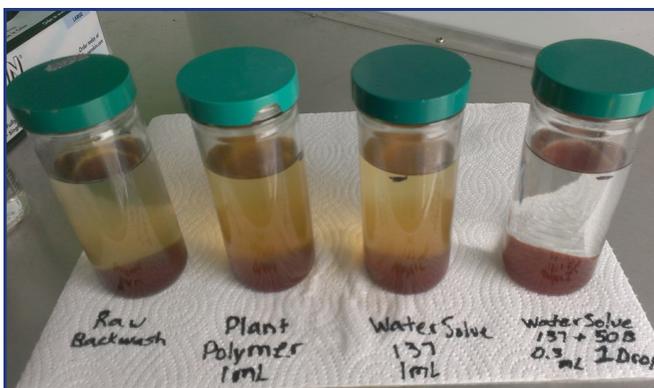
Bench top testing showed a combination of Solve 50B and Solve 137 to be effective in treating the iron backwash residuals.

A representative sample of pond sediment was tested by a technician in the WaterSolve lab. Dewatering polymers were evaluated based on water release rate, water clarity, and flocculent appearance. In addition, dosing rate(s) were determined during bench-top testing and recommendations provided to the facility during this phase of the program. As shown below, Solve 137 and Solve 50B were the recommended polymers for dewatering this residual into the Geotube® containers. WaterSolve, LLC was tasked to provide the Geotube® containers, chemistry, chemical feed equipment, and technical assistance to filter and collect the suspended solids in the backwash sludge lagoon at the Water Treatment Plant.

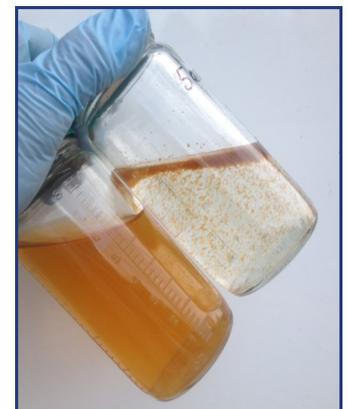
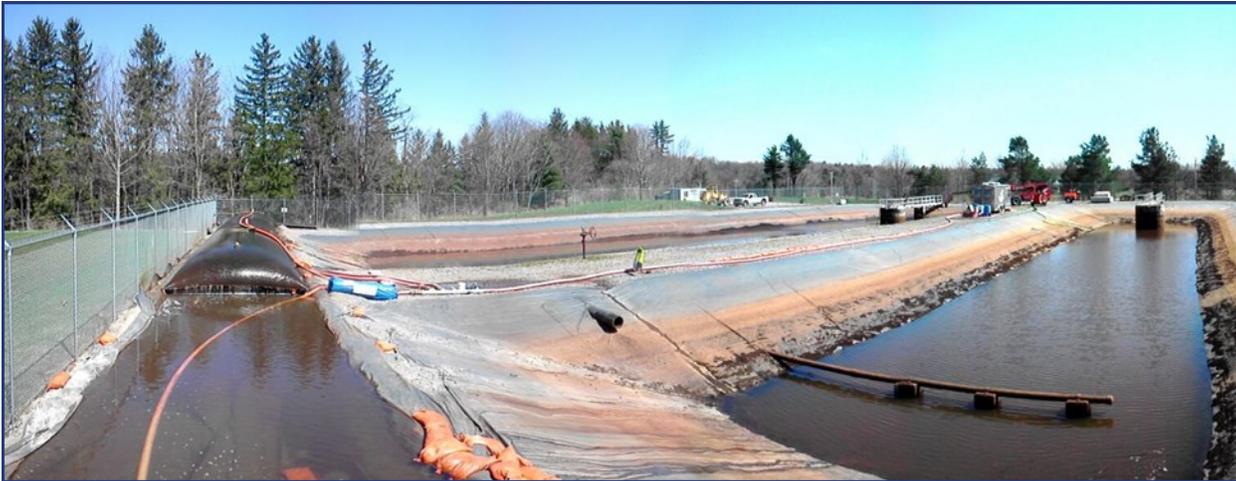
Iron residuals were pumped from the settling ponds to the Geotube® containers. After being treated the filtrate was then discharged into a nearby river.

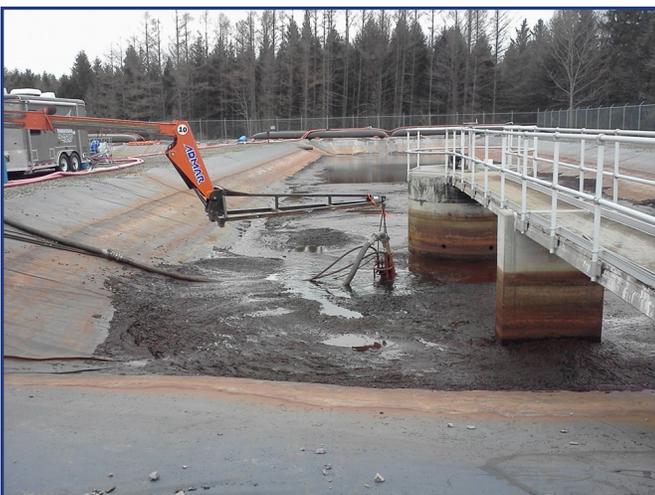
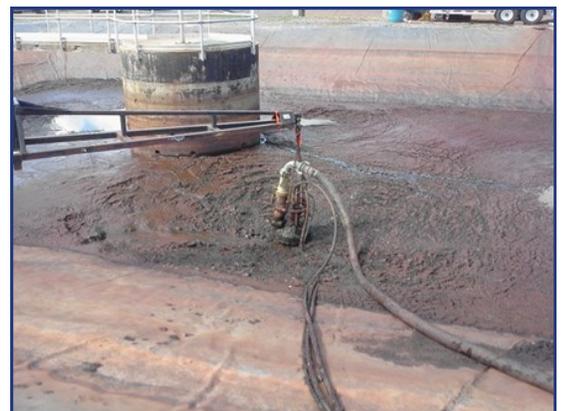
On left is Iron backwash sludge being pumped from the main settling pond. On right is a close up picture of the hydraulic pump.

A Geotube® containment pad was constructed adjacent to the lagoon and a liner was placed in the containment area to collect filtrate water exiting the Geotube® containers and direct it to the other lagoon. Three of the Geotube® containers were deployed within this containment. A 6" hydraulic pump was placed in the lagoon with a telescoping forklift and it transferred the residual to the Geotube® containers through a 4" hose. A chemical feed system injected polymer into the mixing manifold prior to the tubes to flocculate the residual. Chemical feed pumps metered the polymer into the 4" feed line. A sample port provided visual observation of the flocculation and adjustments were made to the chemistry as needed. During operations, the water level was dropped in the main settling pond where only the backwash sludge was remaining. Some of this backwash sludge was used to fill the fourth Geotube® container which would later be pumped out via vacuum truck along the remaining sludge in the main settling pond. Following completion of the main settling pond, water from the secondary pond was pumped through the Geotube® containers and recycled to lower the iron and aluminum concentrations in the water. To ensure the residual met discharge limits per permit specifications, bag filters provided additional treatment. Following chemical treatment and being processed through the bag filters, the filtrate was discharged.
