Petaluma Bridge Construction Project

Volume 325

September, 2013

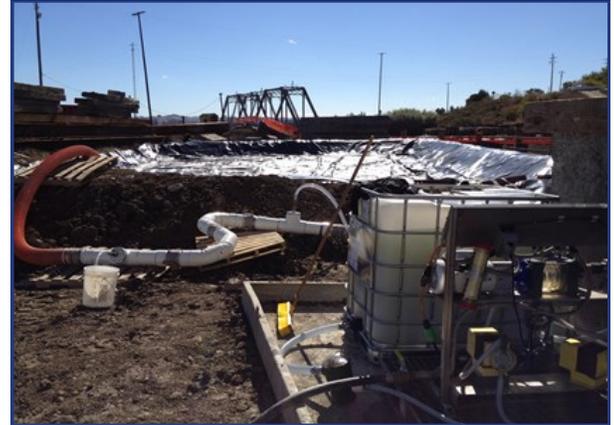
Lay-down area with chemical feed unit and mixing manifold.

Watersolve, LLC technicians completed on-site bench tests to evaluate what polymer provided the most effective water release rate, water clarity and flocculent appearance. Solve 163 exhibited excellent results and would meet or exceed the site objectives. Since the filtrate coming out of the Geotube® container would be discharged directly back into the caisson, controlled and managed feed of the chemical was critical to ensure limited residual polymer returning to the river. Throughout the 48 hours of dredging, WaterSolve technicians ran china clay test on the filtrate water to determine if any residual polymer existed. Of the 30 tests run, all results showed undetectable residual polymer levels.

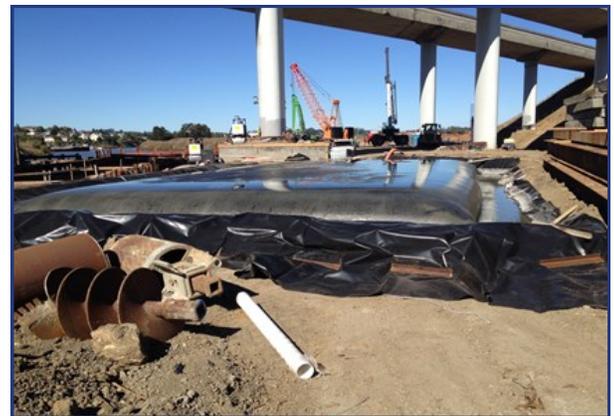
Geotube® container being filled.

Geotube® containers are manufactured from high strength polypropylene fabric and designed to allow effluent water to escape through the pores of the fabric while retaining the chemically-conditioned solids. For this particular site, operational aspects and space were the determining factors for sizing the Geotube® container. It was critical to have a single Geotube® container that would allow for continuous dredging for up to 48 hours. One 75' x 120' Geotube® container was deployed which was folded over to a length of 60'. This allowed for a maximum fill height of 7.5' and 30% more solid capacity than would ultimately be required.

Commercial divers were hired to dredge the slurry seal out of the caisson, and in just under 48 hours all of the material was removed from the caisson. The contractor waited an additional 24 hours for the solids in the Geotube® container to dewater and cut the Geotube® container open, excavated the material out and hauled everything off-site for disposal.

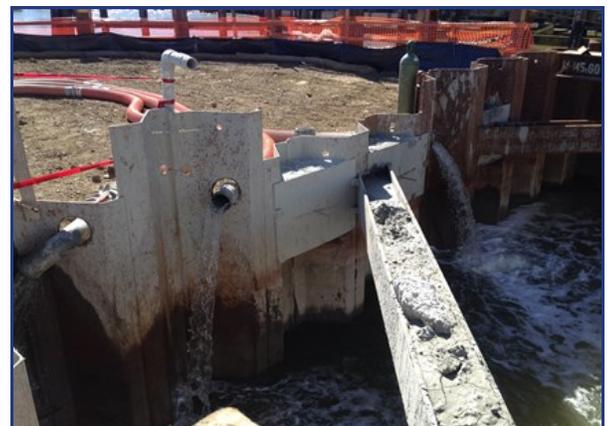
Filtrate water gravity fed back into the caisson. Samples were collected here for China Clay Testing.
