Dredging Sediment from a Settling Pond into Geotube® Containers

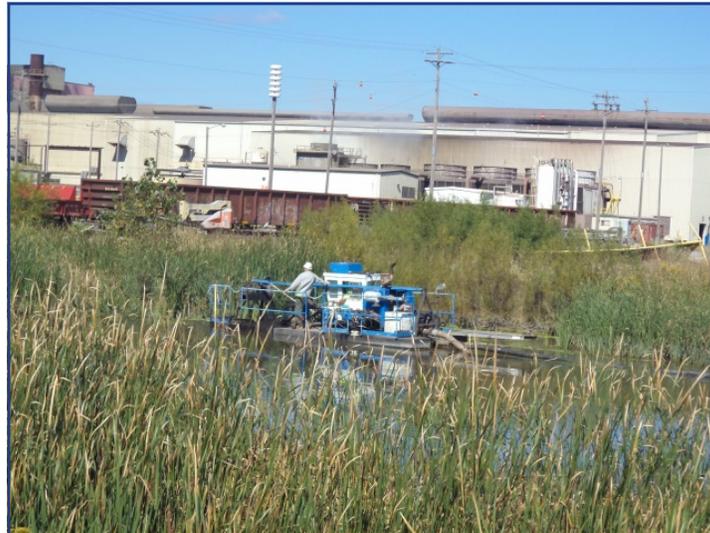
The dredge is approaching the bank as it removes the residual and pumps it to the Geotube® containers.

The dredge contractor used a 6" pipeline to transfer the residual from the dredge to the Geotube® containers. The Solve 426 was injected into the pipeline at a rate of 6-gallons per hour and the Solve 154 was made-down and injected at a rate of 6 to 9 gallons per hour. The filtrate water was pumped back to the settling pond with a 4" hydraulic pump. The environmental manager on site was very happy with the clarity of the filtrate being pumped back to the pond. Cattails around the perimeter of the pond offered a challenge for the dredge operator, but the project was very successful in getting the pond clean and the residual dewatered by the Geotube® containers.

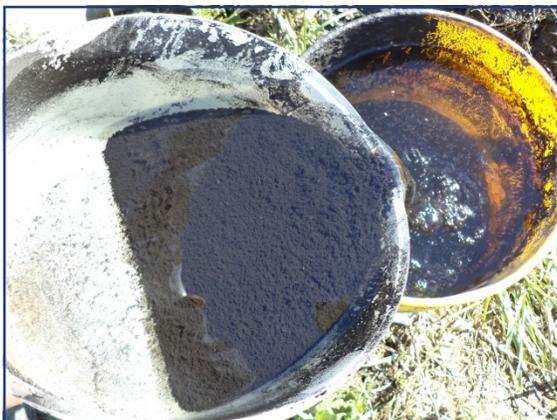
The sample taken from a sample port reveals excellent flocculation and water clarity.

A representative sample of the pond sludge was tested by a WaterSolve technician in the WaterSolve laboratory. Dewatering polymers were evaluated based on water release rate, water clarity, and flocculent appearance. A dual treatment using a coagulant (Solve 426) followed by a flocculant (Solve 154) was selected as the best treatment to produce the water release, clarity, and flocculation needed for this residual.

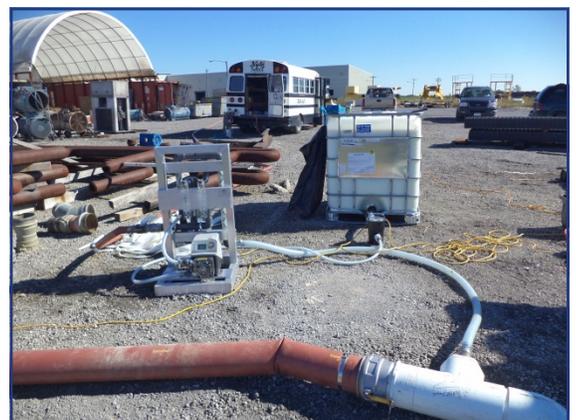
The polymer make-down unit is diluting the Solve 154 flocculent and injecting it into the 6" pipeline.

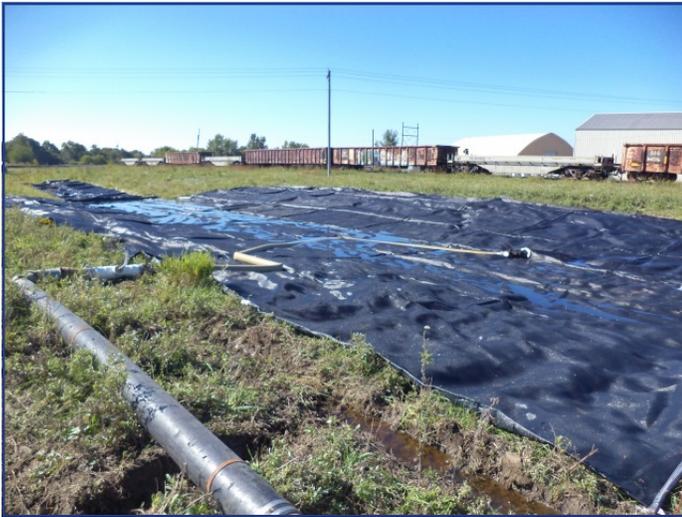
Pumping has begun and the Geotube® containers are beginning to dewater the pond residual.

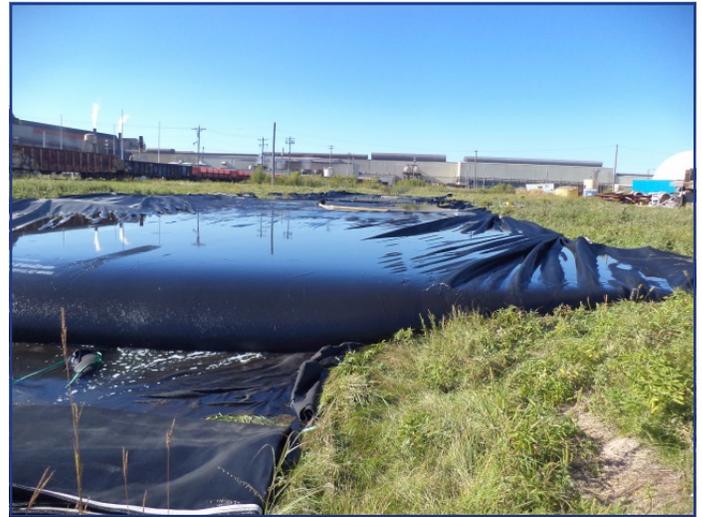
This Geotube® container is beginning to rise as it is being filled. It is dewatering very well.

Geotube® containers are manufactured from high strength polypropylene fabric and designed to allow effluent water to escape through the pores of the fabric while retaining the chemically-conditioned solids. Measurements of the residual in the ponds indicated there was 4,000 cubic yards of residual to be removed. WaterSolve recommended 3 Geotube® containers 120' circumference by 100' long totaling 4,380 cubic yards of usable space for this project.
