Michigan Oil Spill Cleanup

Volume 330

October, 2010

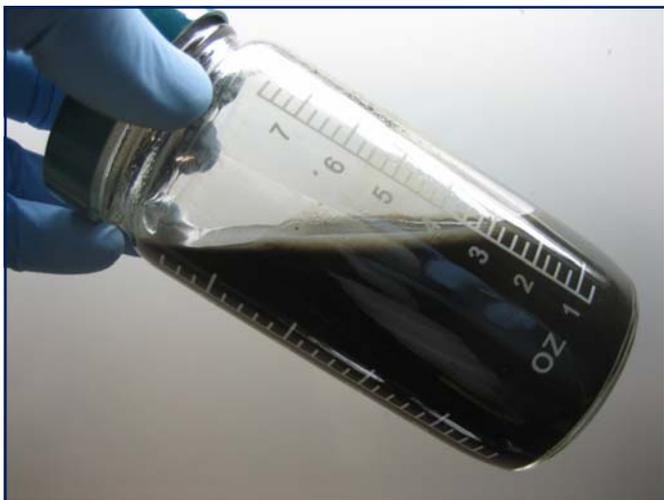
Sample of river sediment before WaterSolve's chemical treatment.

A representative sample of the river sediment was sent to WaterSolve where a dewatering trial was performed to determine the best polymer treatment program. Dewatering polymers were evaluated based on water release rate, water clarity, and flocculent appearance. In addition, dosing rate(s) were determined during bench-top dewatering experiments and recommendations provided to the general contractor during this phase of the program. Solve 426 (a coagulant) followed by Solve 137 (a flocculent) in a 1 to 3 dilution ratio was the recommended chemical treatment for this sediment. Extensive testing was completed with the contractors and engineer prior to the commencement of work.

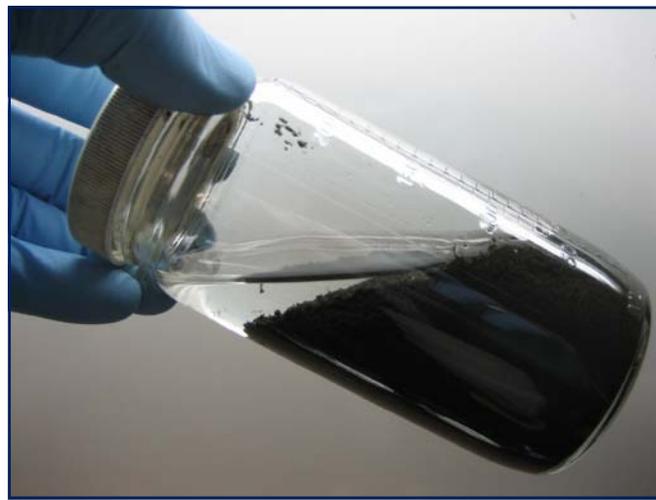
The result after WaterSolve's chemical treatment.

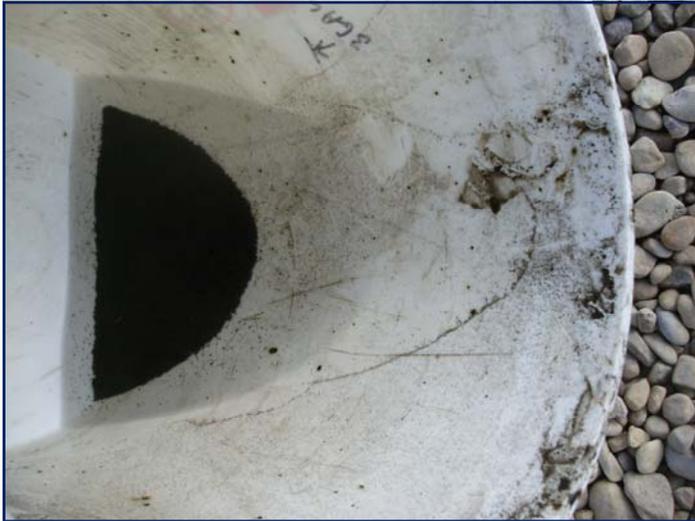
The sample port was used to monitor the chemical conditioning. This sample shows excellent solids separation and water clarity.

WaterSolve was contracted to provide the chemistry, chemical feed equipment, and the technicians to manage the chemical conditioning. Upon arrival at the site WaterSolve technicians assembled the polymer feed system to inject the chemistry into the 8" dredge pipeline. A ten gallon per hour chemical feed pump injected the Solve 426 (coagulant) directly into the pipeline. The Solve 137 (flocculent) was made-down (diluted) with a polymer make-down unit with a 10-gph polymer progressive-cavity pump and injected into the pipeline after the Solve 426. A sample port was placed in the pipeline to provide visual samples of the chemical treatment. Adjustments were made to the chemical feed rates based on these samples. A log of the hourly feed rates as well as the daily consumptions of each chemistry and notable changes was recorded and given to the contractor at the end of each day.

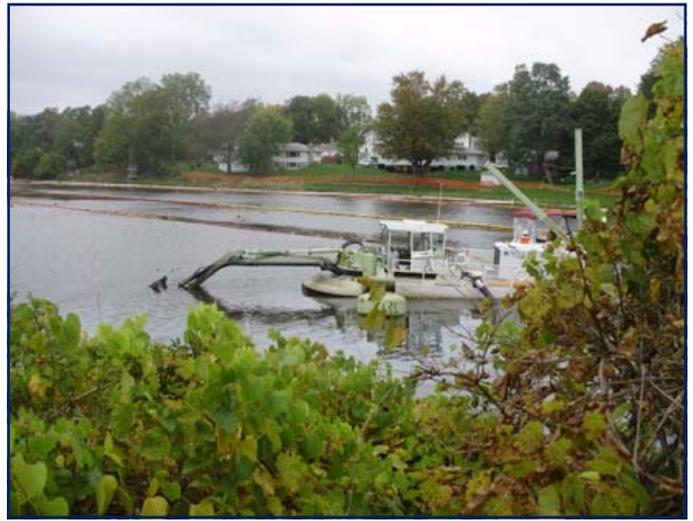
This amphibious dredge captured the sediment and pumped it to the geotextile tubes.

A second and third dredge was plumbed into the pipeline during the project to speed up the process as the contractor was under a major deadline. WaterSolve was able to treat the sediment from the dredges without any interruption to the project. The chemical treatment was excellent. Filtrate water exiting the tubes made its way to a sump and was pumped through a water treatment plant to capture any remaining contaminants prior to returning to the river. The residual in the tubes was dry enough to haul away a month after the last water was pumped to them. The contractor successfully completed the project before the deadline and the process was deemed a success.

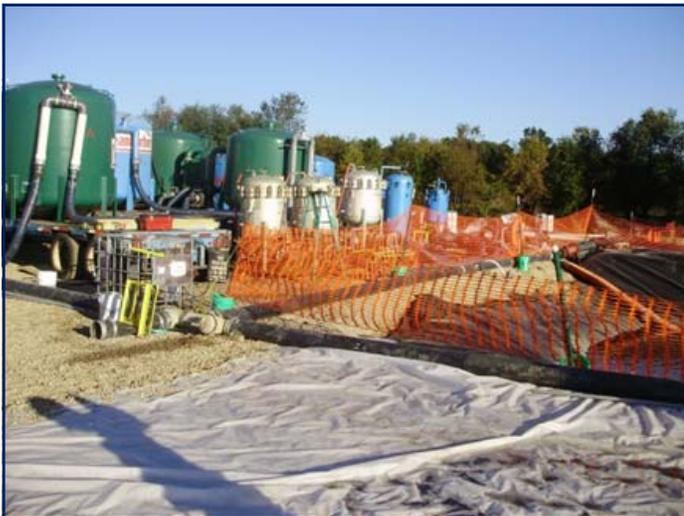
This water treatment plant drew water from the sump and removed any remaining contaminants before sending it back to the river. The chemical feed equipment was located between the sump and the water treatment equipment adjacent to the dredge line as shown.

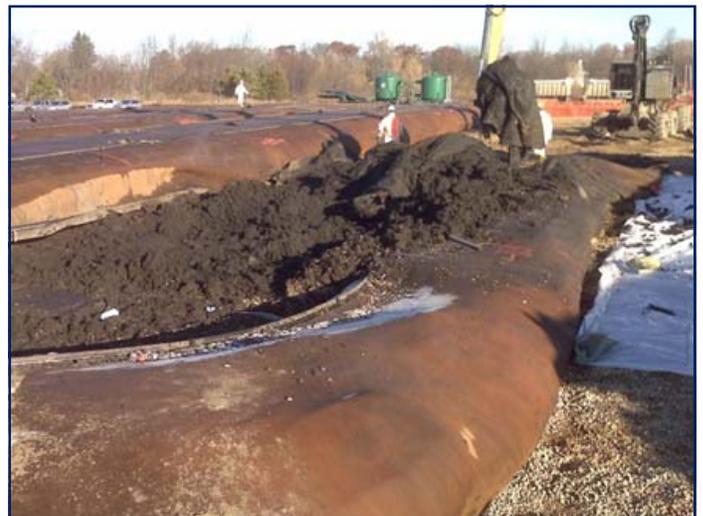
The river sediment dewatered in the geotextile tubes is being loaded and hauled away for disposal.
