Lagoon Cleaning with Geotubes® to Upgrade the System

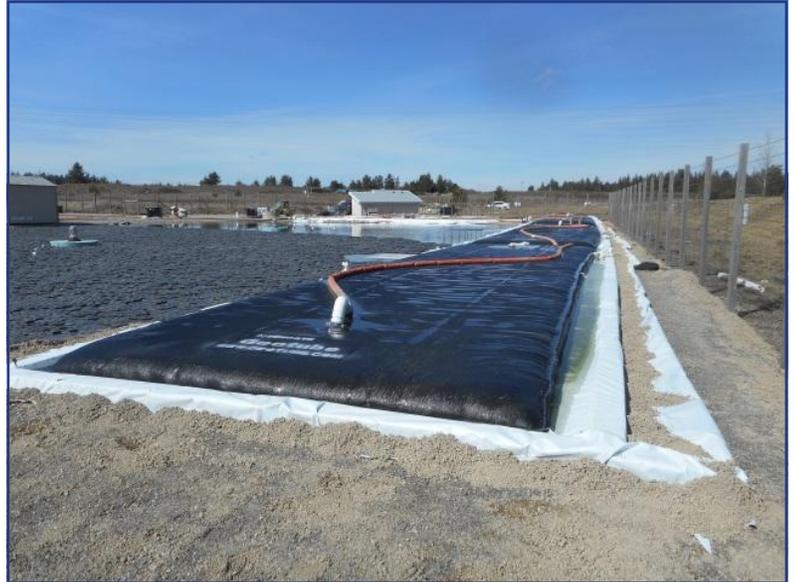
#1 A Geotube® containment pad was placed adjacent to the lagoon. The liner was placed over railroad ties and secured with gravel and sand bags.

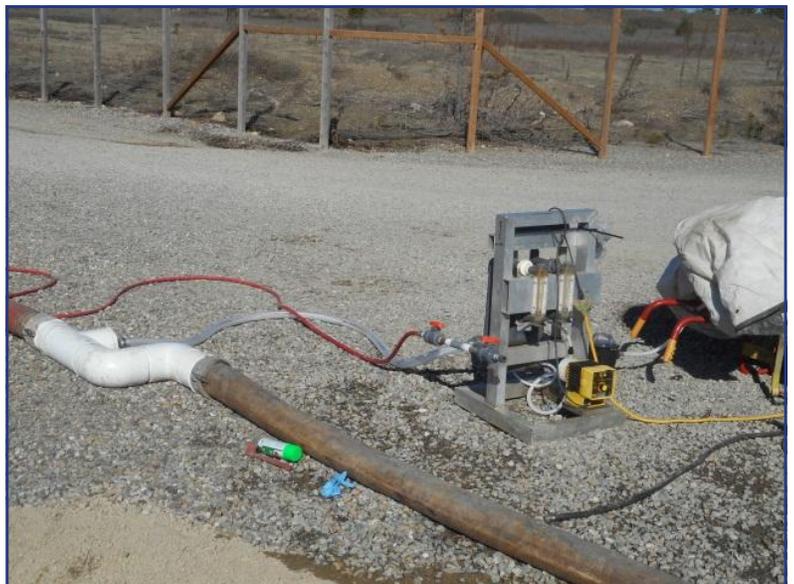
#2 The polymer make-down unit injected Solve 9244 polymer into the pipeline prior to the Geotube® containers.

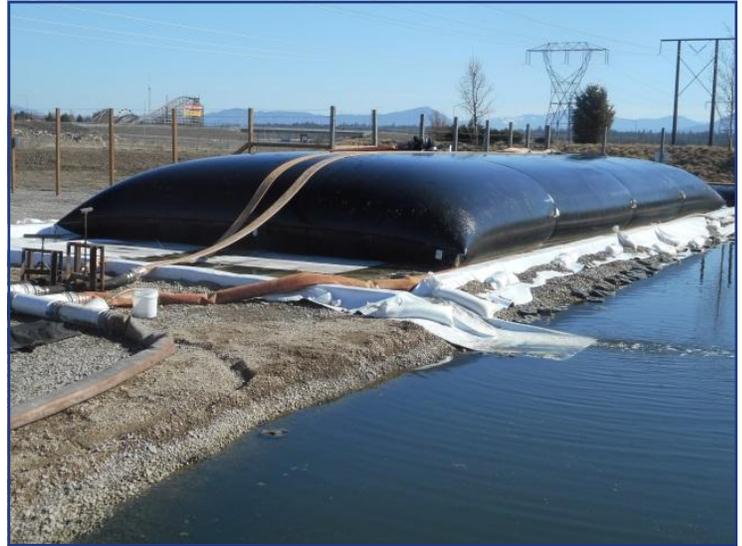
#3 This Geotube® container is filling and dewatering very well. The filtrate water is returning to the lagoon on the lower right of the photo.

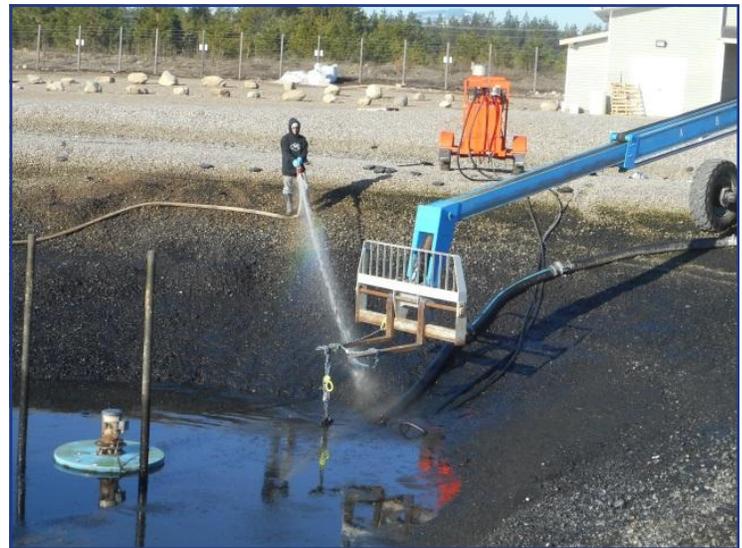
#4 This lagoon is almost empty. A 6” hydraulic pump is removing the biosolids as the walls are being sprayed.

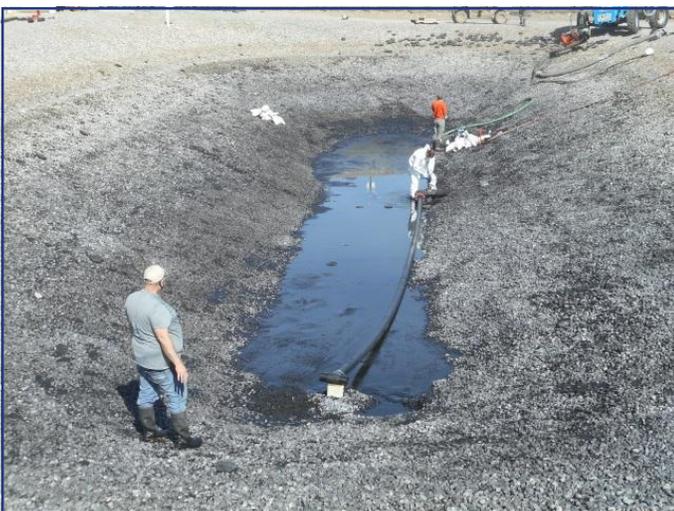
Once the lagoons were empty improvements were installed.
